Building Condition Report

Project: Foundation Investigation

1. Introduction:

LEEKOR Engineering Inc. has been retained by xxxxx to conduct an investigation of the basement foundation following the flash flood which occurred on xxxx located at xxxxx.

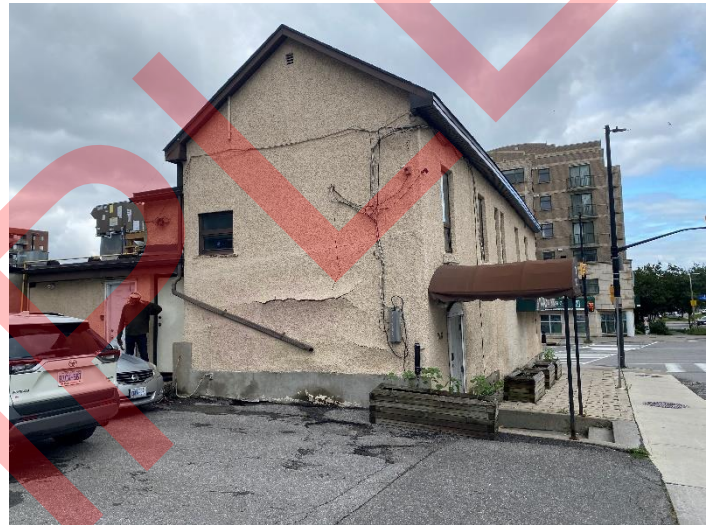
Photograph 1

- View of the south façade.
- The rainwater leader is directing water onto the side of the building.
- Add an extension to the end of the leader to direct water away from the foundation.

1. As a temporary measure fill the sink hole with lean-mix concrete.
2. Clean all debris from the exterior trench drain.
3. Clean all debris from the basement sump and ensure that the pump is operating.
4. Add an extension to the end of the leader to direct water away from the foundation.
5. It is recommended to excavate along the south foundation wall in order to investigate the condition of the basement wall and provide a solution to repair and waterproof the wall.

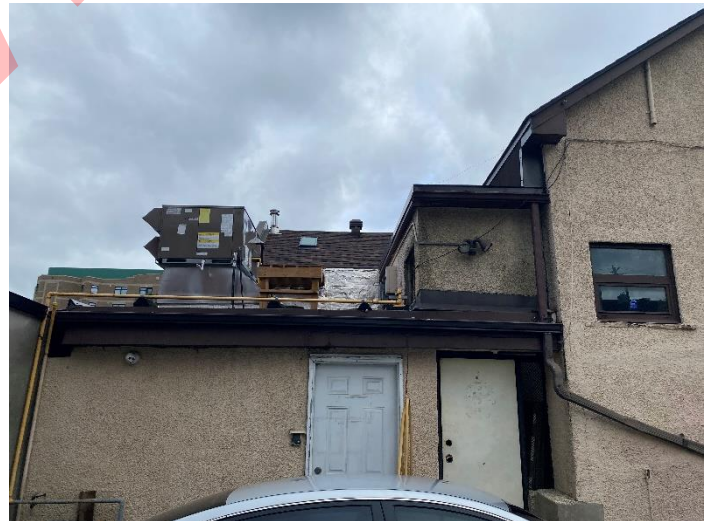
Photograph 2

- The upper eaves trough is draining into the leader and directing water onto the side of the building.

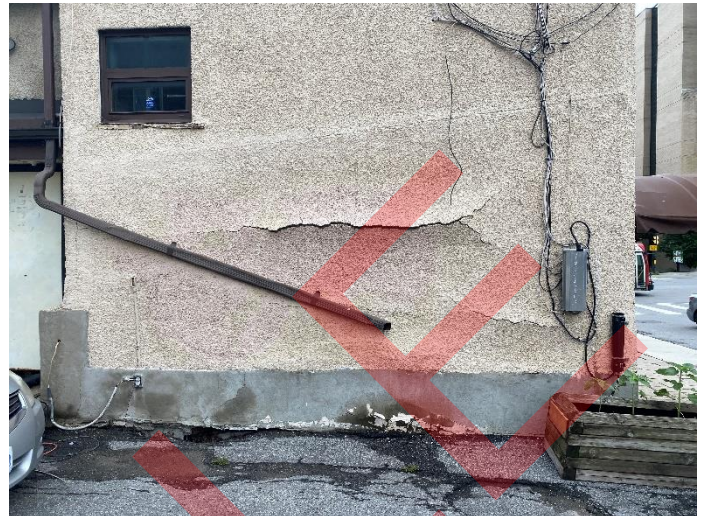
Photograph 3

- A sink hole at the foundation allows water and soil to penetrate through the foundation into the basement.
- As a temporary repair fill the void with a lean mix concrete.

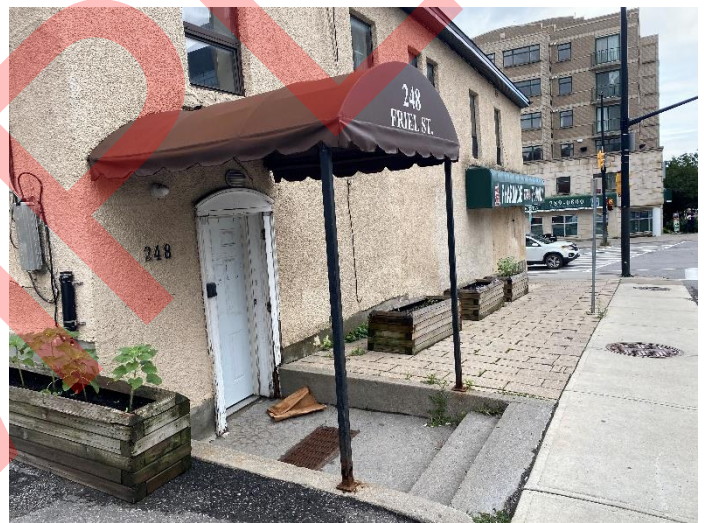
Photograph 4

- The trench drain has debris below the grating.
- Clean all debris from the drain and ensure there is proper drainage.

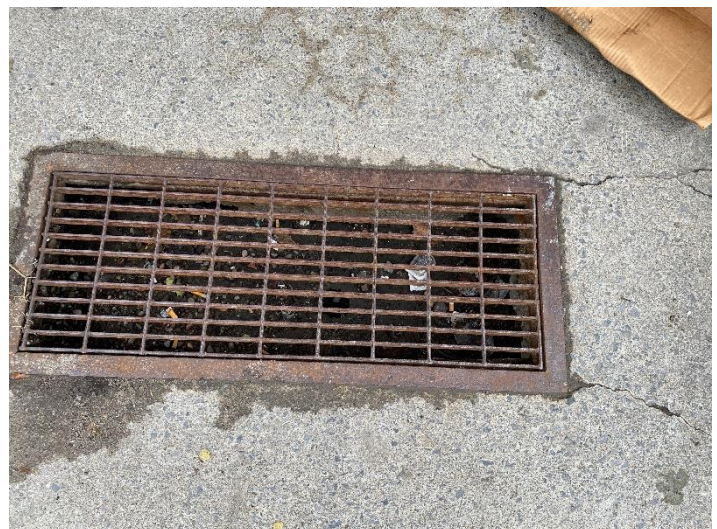
Photograph 5

- View of the debris in the drainage trench.

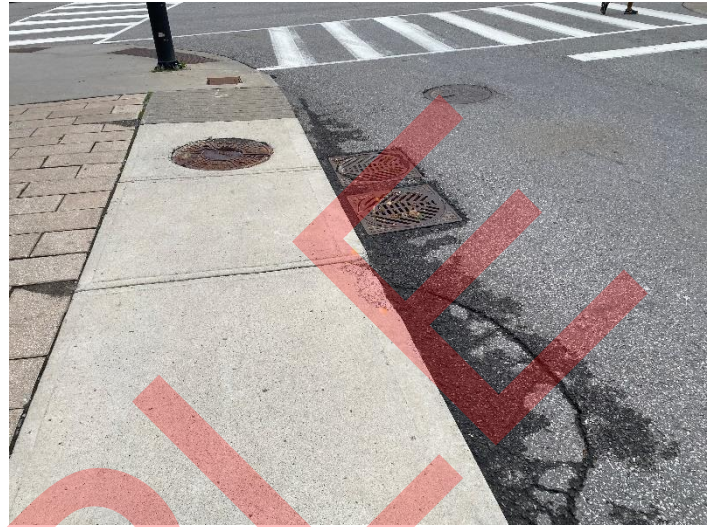
Photograph 6

- The city drain to the right of the sidewalk is covered with a filter cloth preventing it from capturing any runoff.

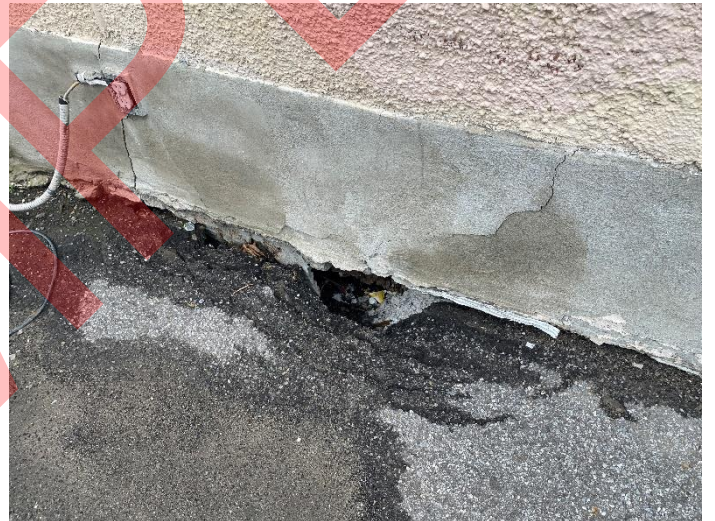
Photograph 7

- View of the sink hole at the foundation wall.

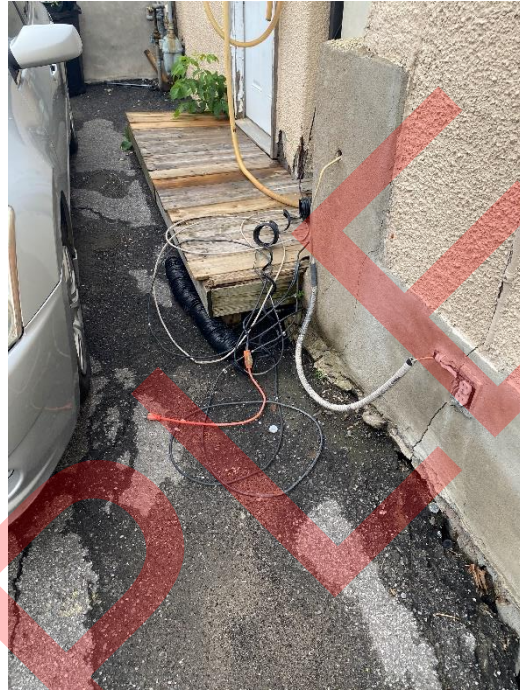
Photograph 8

- There are gaps along the length of the foundation wall.

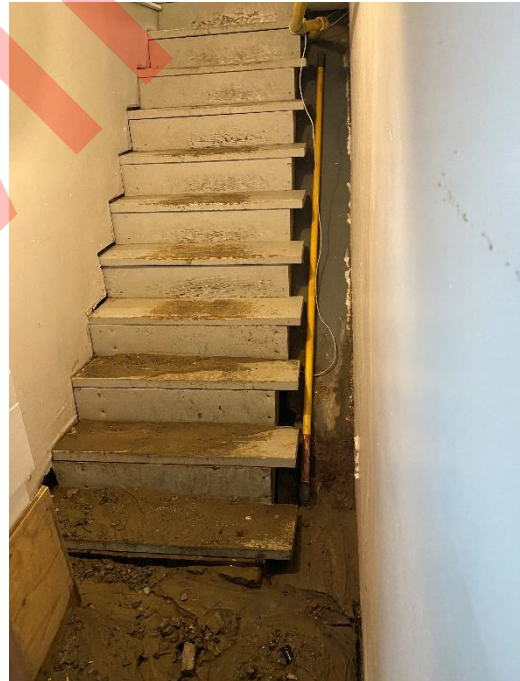
Photograph 9

- Water and soil have infiltrated into the basement at the bottom of the stairs.
- The foundation walls are constructed of rubble.

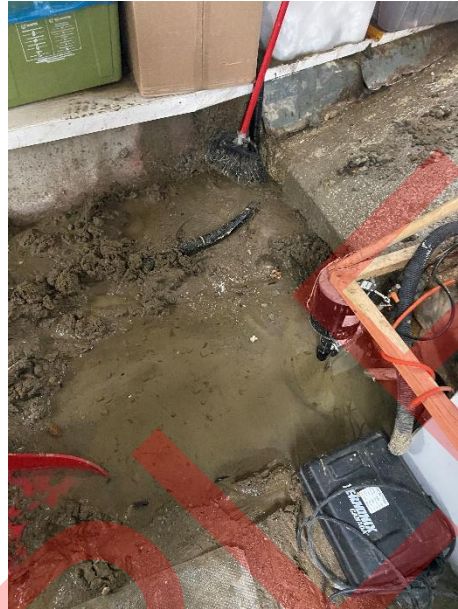
Photograph 10

- The sump is filled up with soil rendering the pump from operating.
- Clean out all debris from the sump.
